# INSTALLATION GUIDE

## TCP RCKM-05

### Manual Rack & Pinion - Left-Hand Drive

### 1971-1973 Mustang/Cougar

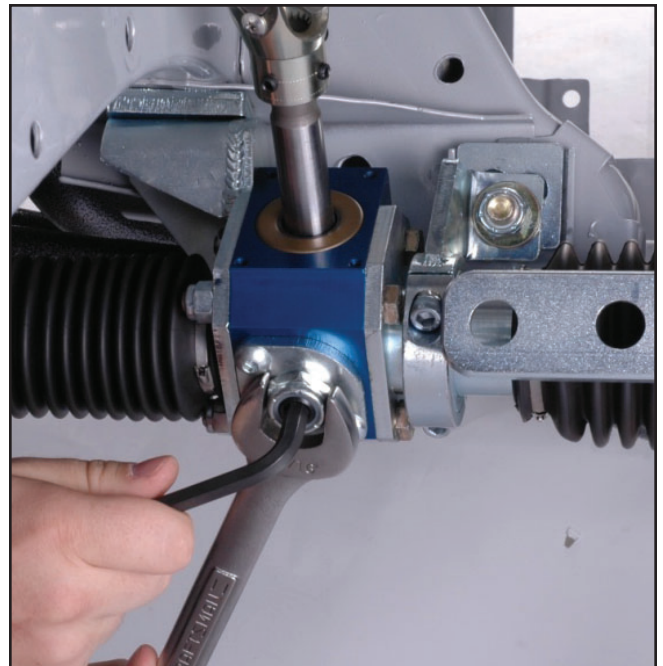
2. Continue by tightening the passenger-side outer clamp to 13-15 lb-ft., and check for binding.
  - **Tightness near full-left lock (manual rack) or center of travel (power rack)** indicates that the passenger-side clamp has created one of the following issues.

- The clamp is too tight and needs to be loosened slightly.
    - The clamp is not square to the bracket-side clamp. Check by measuring the gap at the opposite ends of the clamp.

- There is debris, a burr, or other imperfection on the clamp or rack tube that must be removed.
    - Recheck for binding.
3. Tighten the two inner clamps to 13-15 lb-ft., and check for binding.

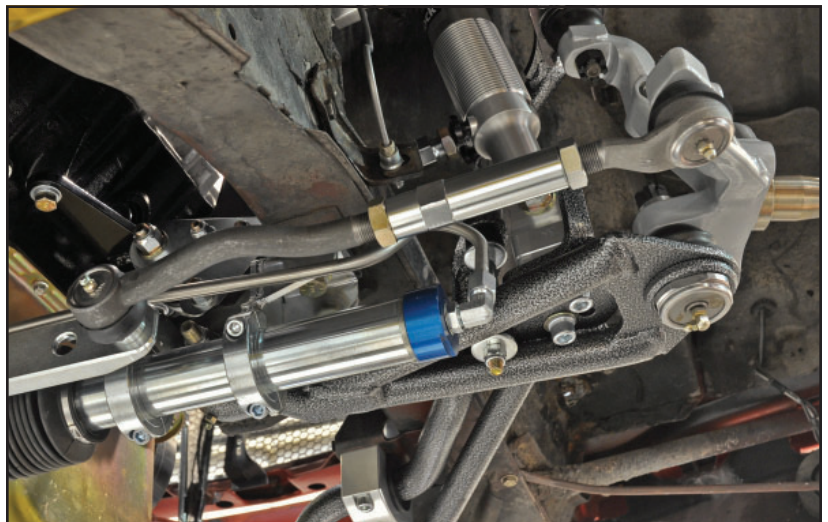
4. Verify that the rack has full travel.
5. Turn the steering wheel to full left lock.
6. From one of the frame rails, measure the distance that the center link travels from full left to full right lock. The rack should travel 6-3/8".
7. If travel is less than 6-3/8", look for binding at the u-joints or with exhaust headers that may be limiting travel.

8. From full right lock, move the center link 3-3/16" toward the left. This is the rack and pinion's center of travel.
9. Tie-rod assemblies can now be installed as described in their respective installation guides (7903-TIER-XX).
10. Installation of inner tie rod requires use of vehicle specific tie-rod adapter packaged with rack and pinion.
11. Adjusting the tie-rods to correctly set the alignment toe must be done with the suspension fully weighted and the rack and pinion at its center of travel.
12. Recheck all hardware for each portion of the steering system (aftermarket and OEM) to ensure it has been tightened to the proper torque specification. The installation for the complete subframe connector package is complete.
